COMPAS_sCO₂

EXTERNAL WALL INVESTIGATIONS RESULTS

COMPAS_sCO₂ Second Stakeholders Workshop

*Next generation advanced materials for
particle/supercritical CO₂ heat exchangers*

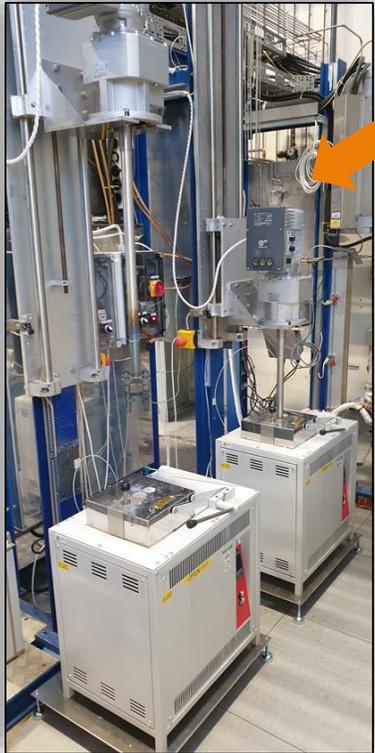
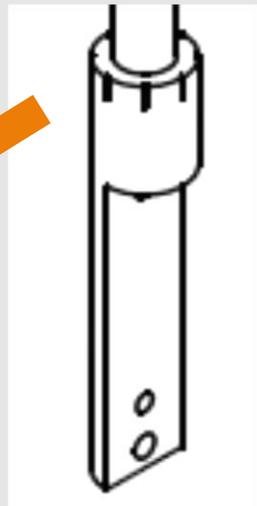
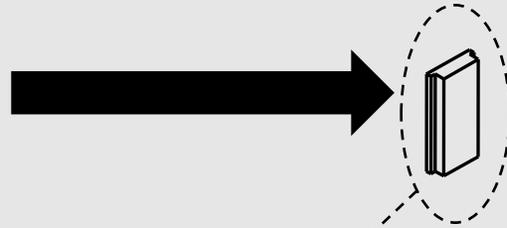
Erosion Testing Facilities at FZJ

sample specimen

surface in contact with granulate (20 mm x 8 mm)

sample holder

particle flow rate = holder rotation speed

top view

Method: impact of granulate (bauxite) on specimens manufactured for erosion testing
Analysis: mass change, metallographic cross-sections (SEM / EDX), optical metallography

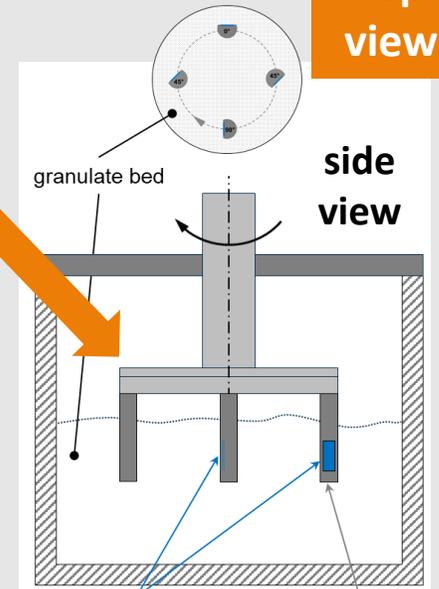
side view

granulate bed

specimens

specimen holder

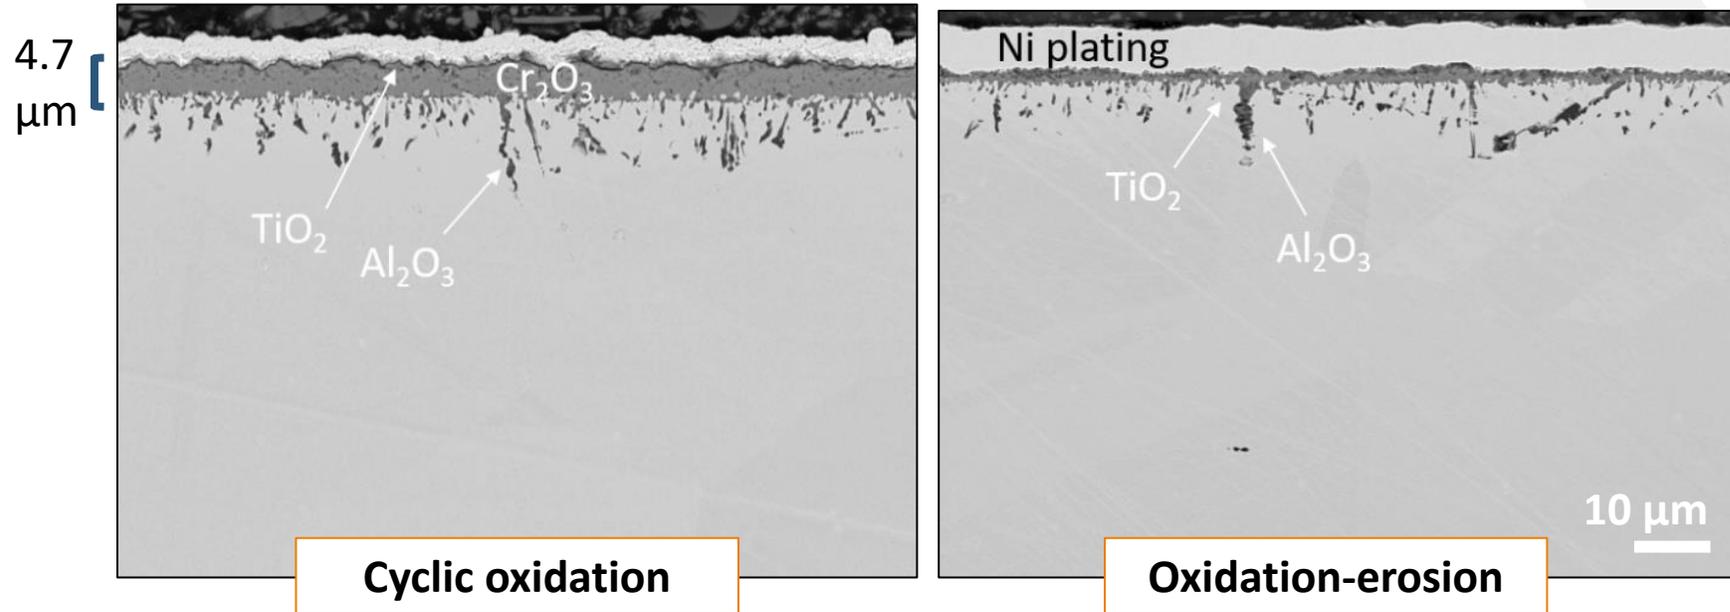
Back scattered electron images of cross-sectioned IN740

Erosion testing performed
at 600 °C (P 92), 700 °C
and 900 °C

The images clearly indicate the rate of material degradation; chromia and titania-rich oxide layers are typically formed, creating a hard barrier on the surface of the material substrate that may enhance corrosion resistance

Exposures for 250 h at 900°C in air

Oxidation-erosion: *sintered bauxite (particle size 300 to 600 μm), provided by Saint-Gobain*

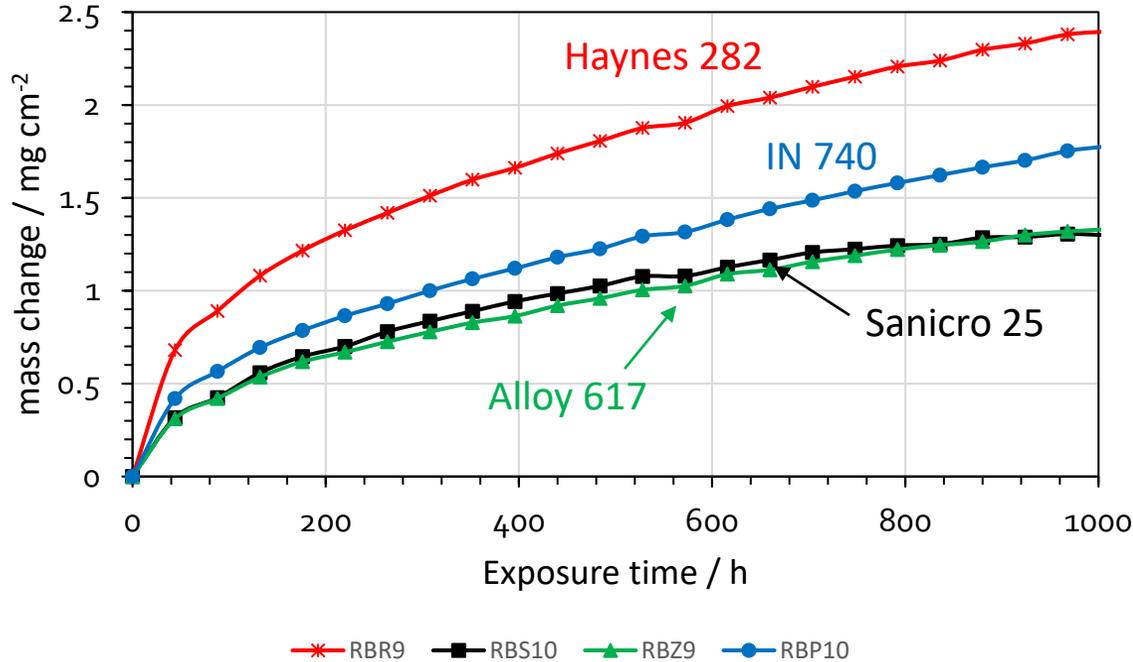
Cyclic oxidation exposure at 900 °C in air

Mass changes relate to total specimen surface area (including sides not exposed to erosion)

The change in thickness of the oxide layers corresponds with the mass change data.

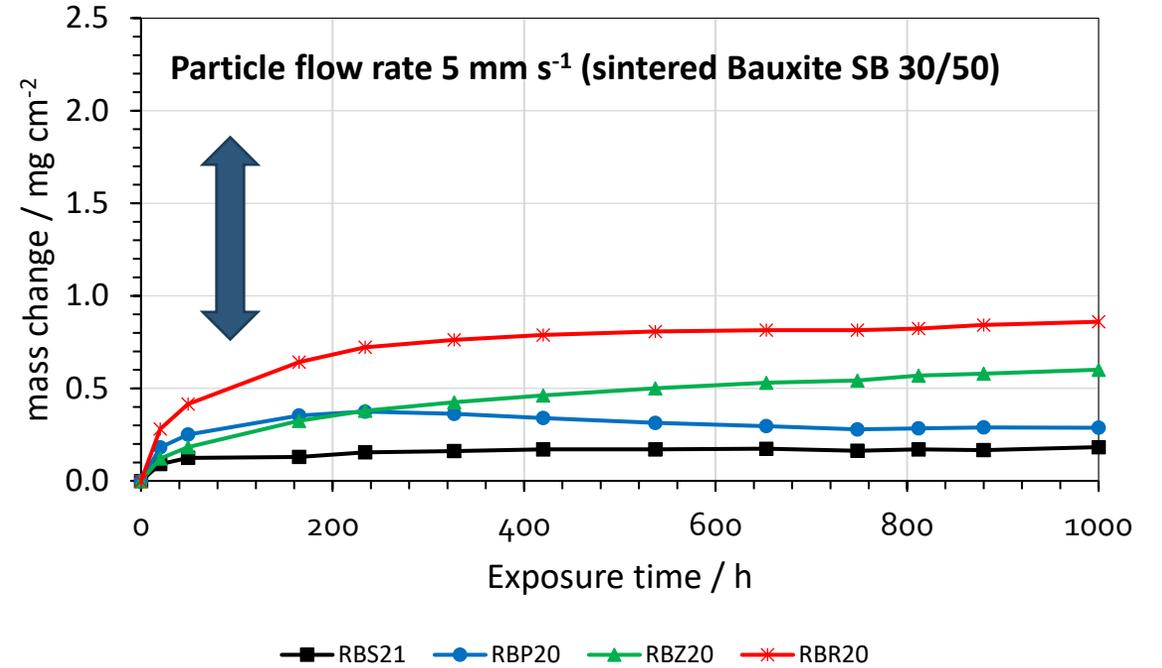
Oxidation and erosion exposure at 900 °C in air

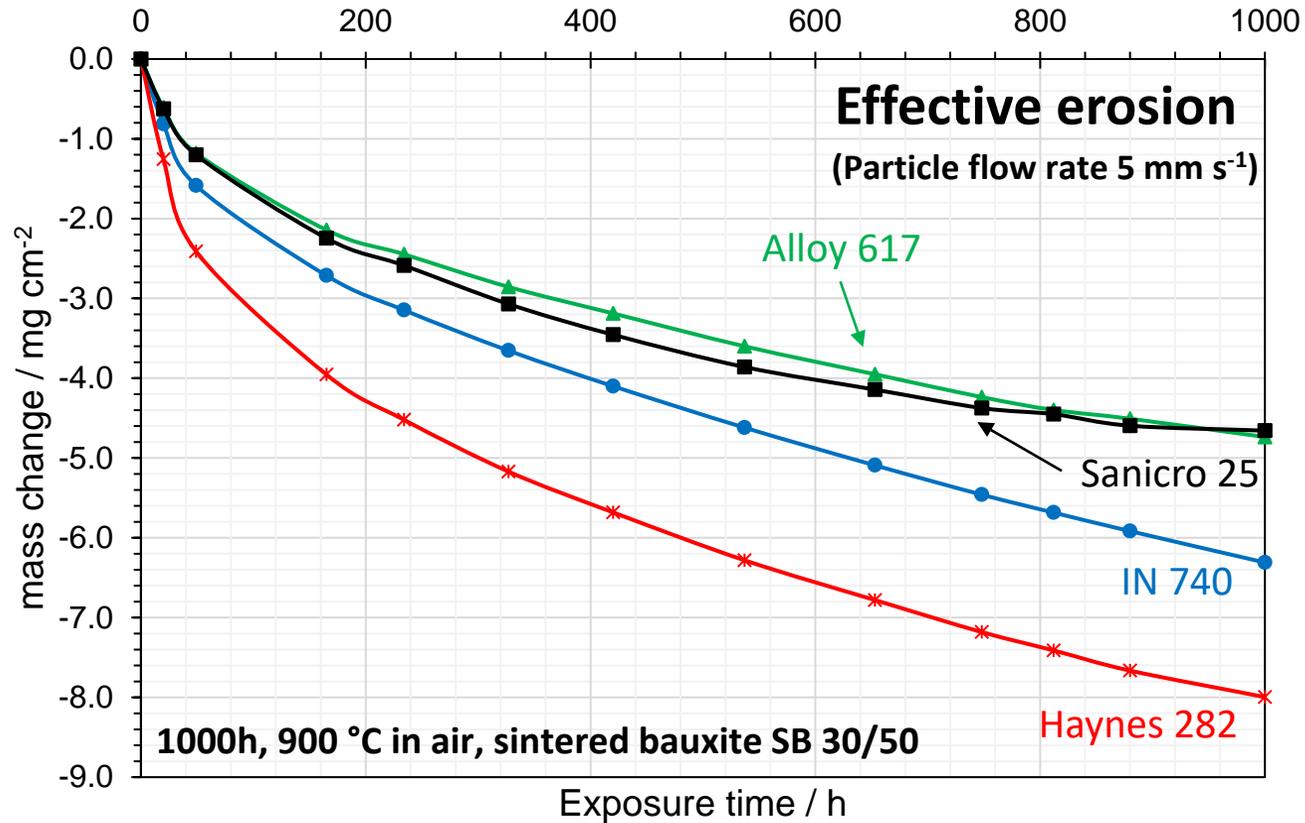
Mass changes relate to front specimen surface area:

$$\frac{(A_{\text{erosion}}^{\text{whole}} \cdot \Delta m_{\text{erosion}}) - (A_{\text{cycl.oxidation}}^{\text{whole}} \cdot \Delta m_{\text{cycl.oxidation}})}{A_{\text{erosion}}^{\text{exposed}}}$$

The highest mass loss is observed in Haynes 282 (–8 mg cm⁻² after 1000h exposure), whereas the lowest is observed in Alloy 617 and Sanicro 25 (<4 mg cm⁻²); both Alloy 617 / Sanicro 25 exhibit similar changes in mass after 1000h exposure)

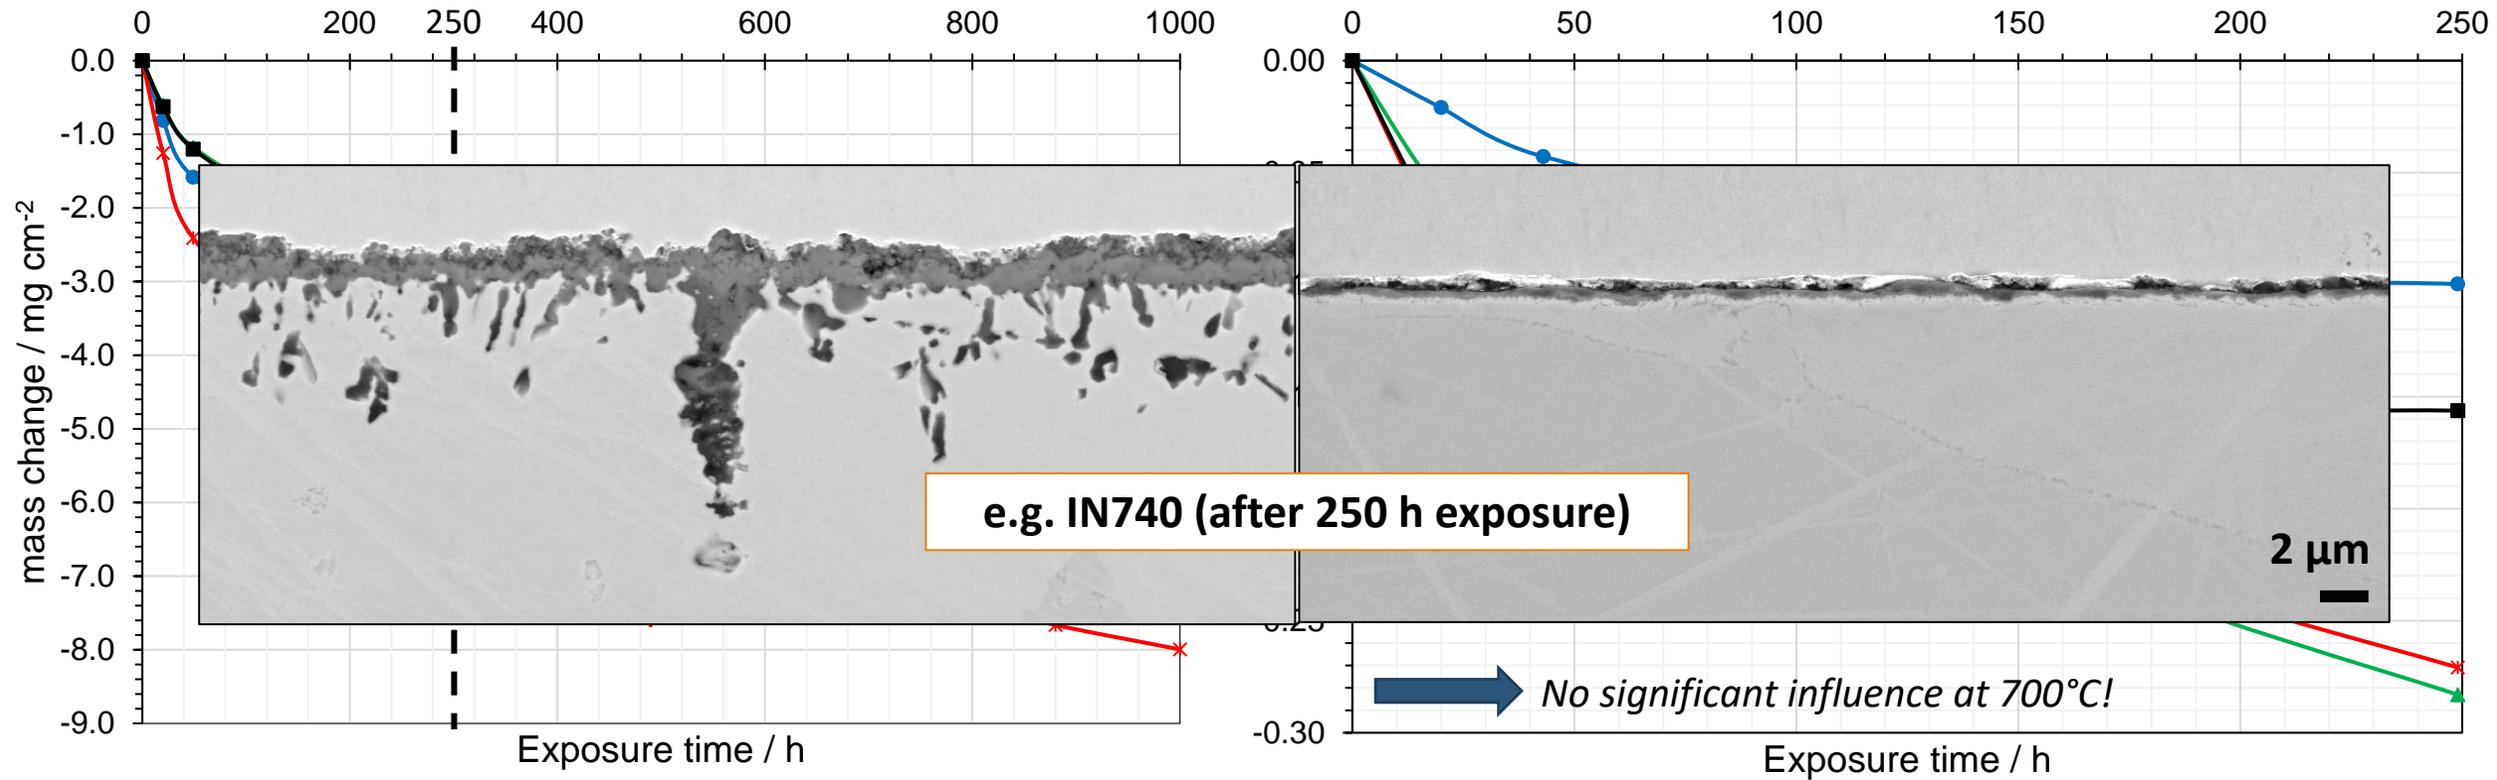
1000h, 900°C in air, sintered bauxite SB 30/50 (5 mm s⁻¹)

250h, 700°C in air, sintered bauxite SB 30/50 (5 mm s⁻¹)

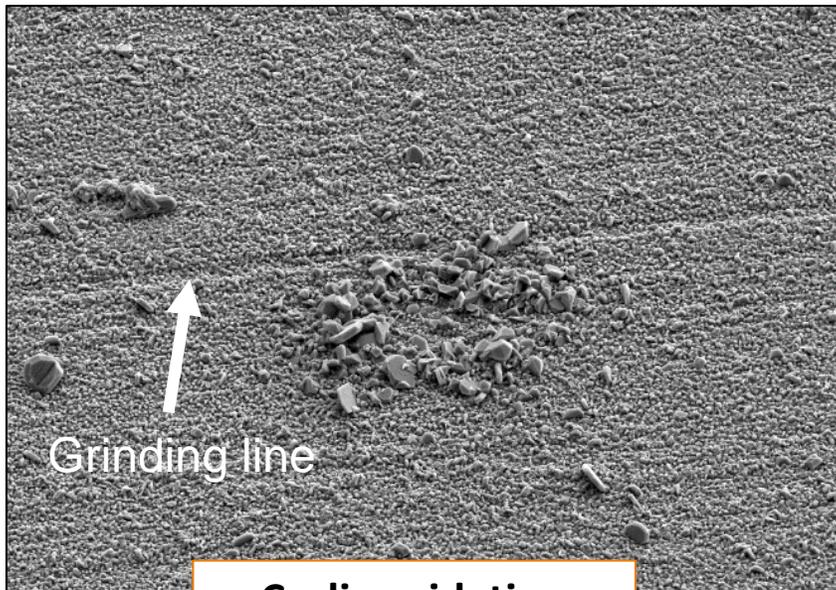
Back scattered electron images of sample specimen surfaces (Alloy 617)

Cyclic oxidation

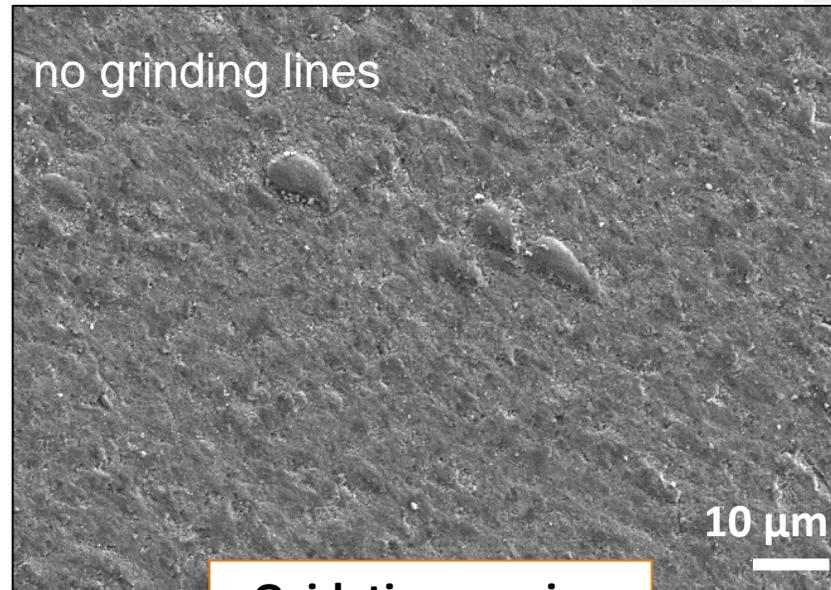
Oxidation-erosion

Impact of erosion rate (5 mm s^{-1}) sufficient to erode whole surface area of the sample, as polishing lines (1200 Grit) could not be observed after erosion-oxidation testing anymore

Exposures for 250 h at 700°C in air

Oxidation-erosion: *sintered bauxite (particle size 0.3 to 0.6 mm), provided by Saint-Gobain*

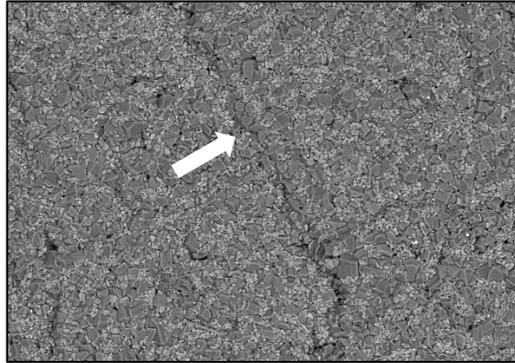
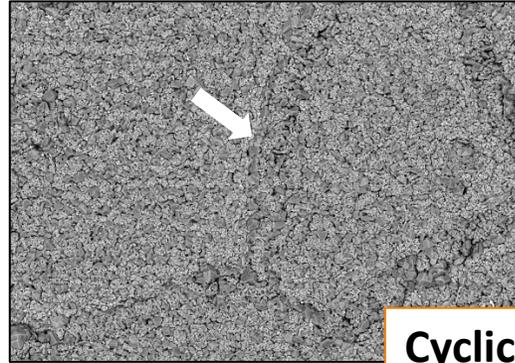
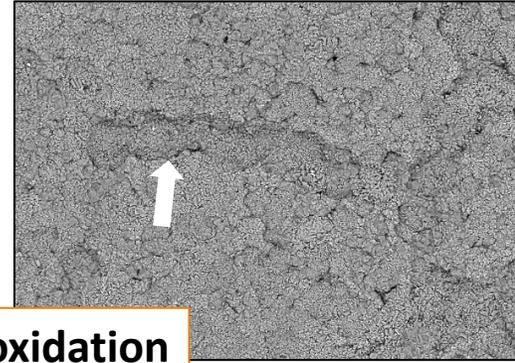
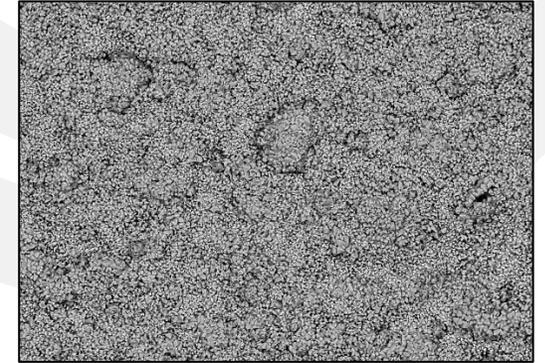
Sample matrix exhibits grain boundary structures

Cyclic oxidation

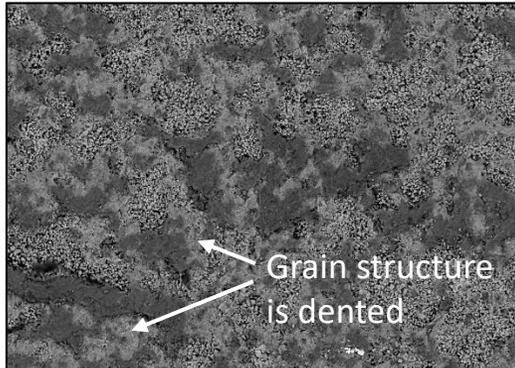
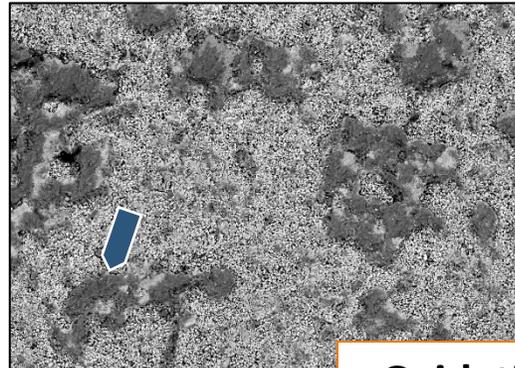
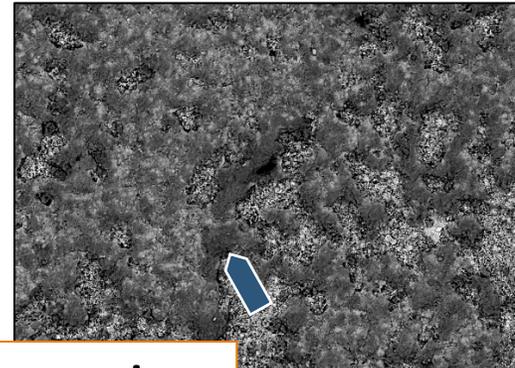
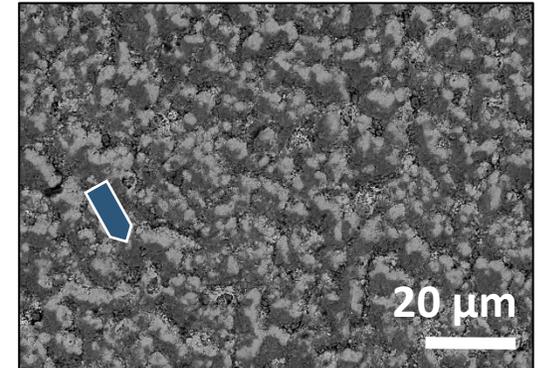
Grain structure is dented

Oxidation-erosion

Granulate impacted on the surface morphology of the alloys

250 h / 900°C

Black discoloration within the sample matrix implies granulate deposition of the bauxite material

- **How can we explain the coherences observed (weight changes and SEM images)?**
- Granulate deposition is a sign of less erosion degradation (mass change data)
- **1st assumption:** possible reason for less erosion degradation might be related to the sample roughness, which is attributed to the chemical composition of the sample
- **2nd assumption:** mechanical properties of oxide scale; specifically, a high Ti-content promotes oxide scale formation which can be susceptible to erosion

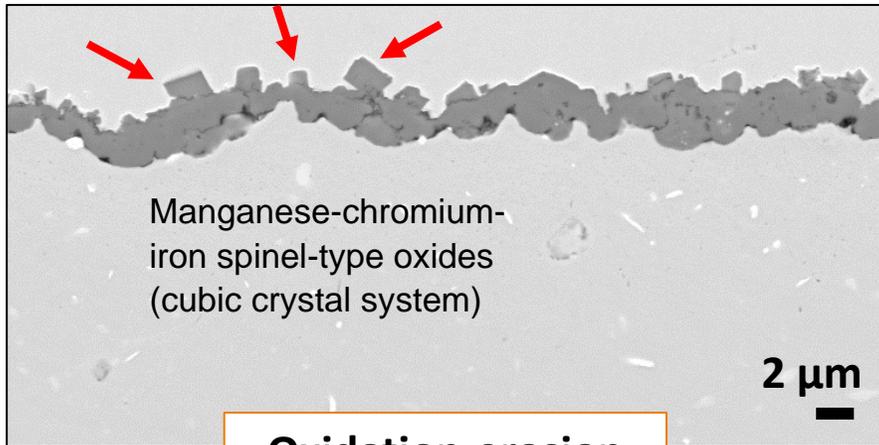
Sanicro 25

Manganese-chromium-iron spinel-type oxides (cubic crystal system)

Oxidation-erosion

Exposures for 250 h at 900°C in air

Oxidation-erosion: sample back side, not exposed to bauxite granulate

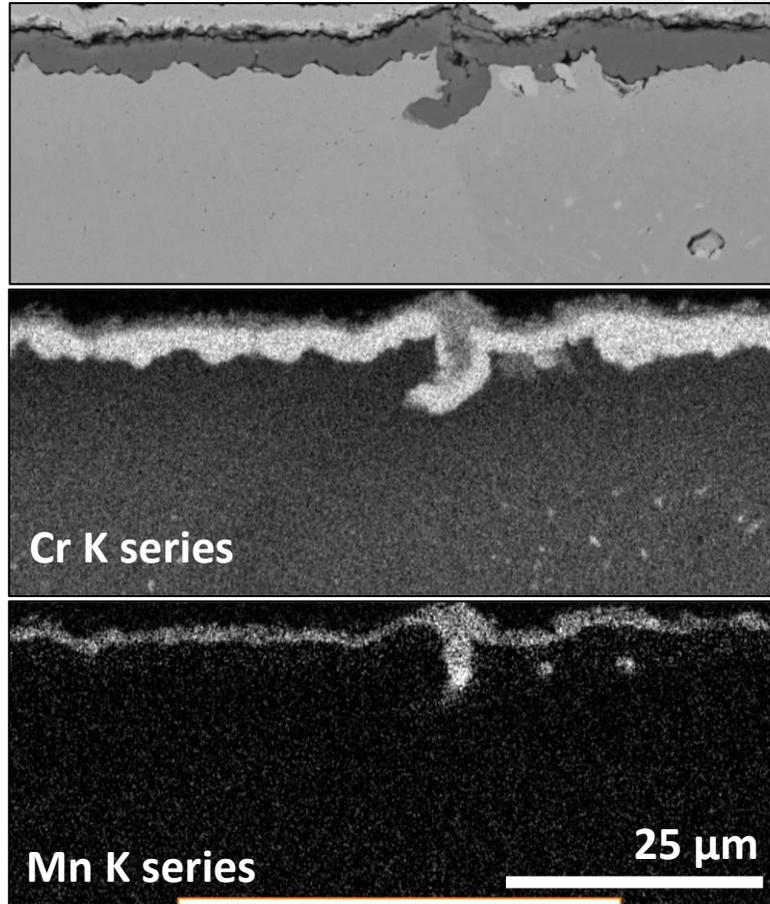
Cr K series

Mn K series

Cyclic oxidation

EDX mapping of the scale formed on Sanicro 25

Mn has accumulated on the surface of the outer layer, suggesting that it has dissolved in the chromia and diffused onto the alloy's surface → it has clearly reacted with the chromia to create **manganese chromia spinell**
